A Report on the Preservation of

# BUDDHIST MONUMENTS

At Bamiyan in Afghanistan

By: Dr. B.B.Lal and R.Sengupta

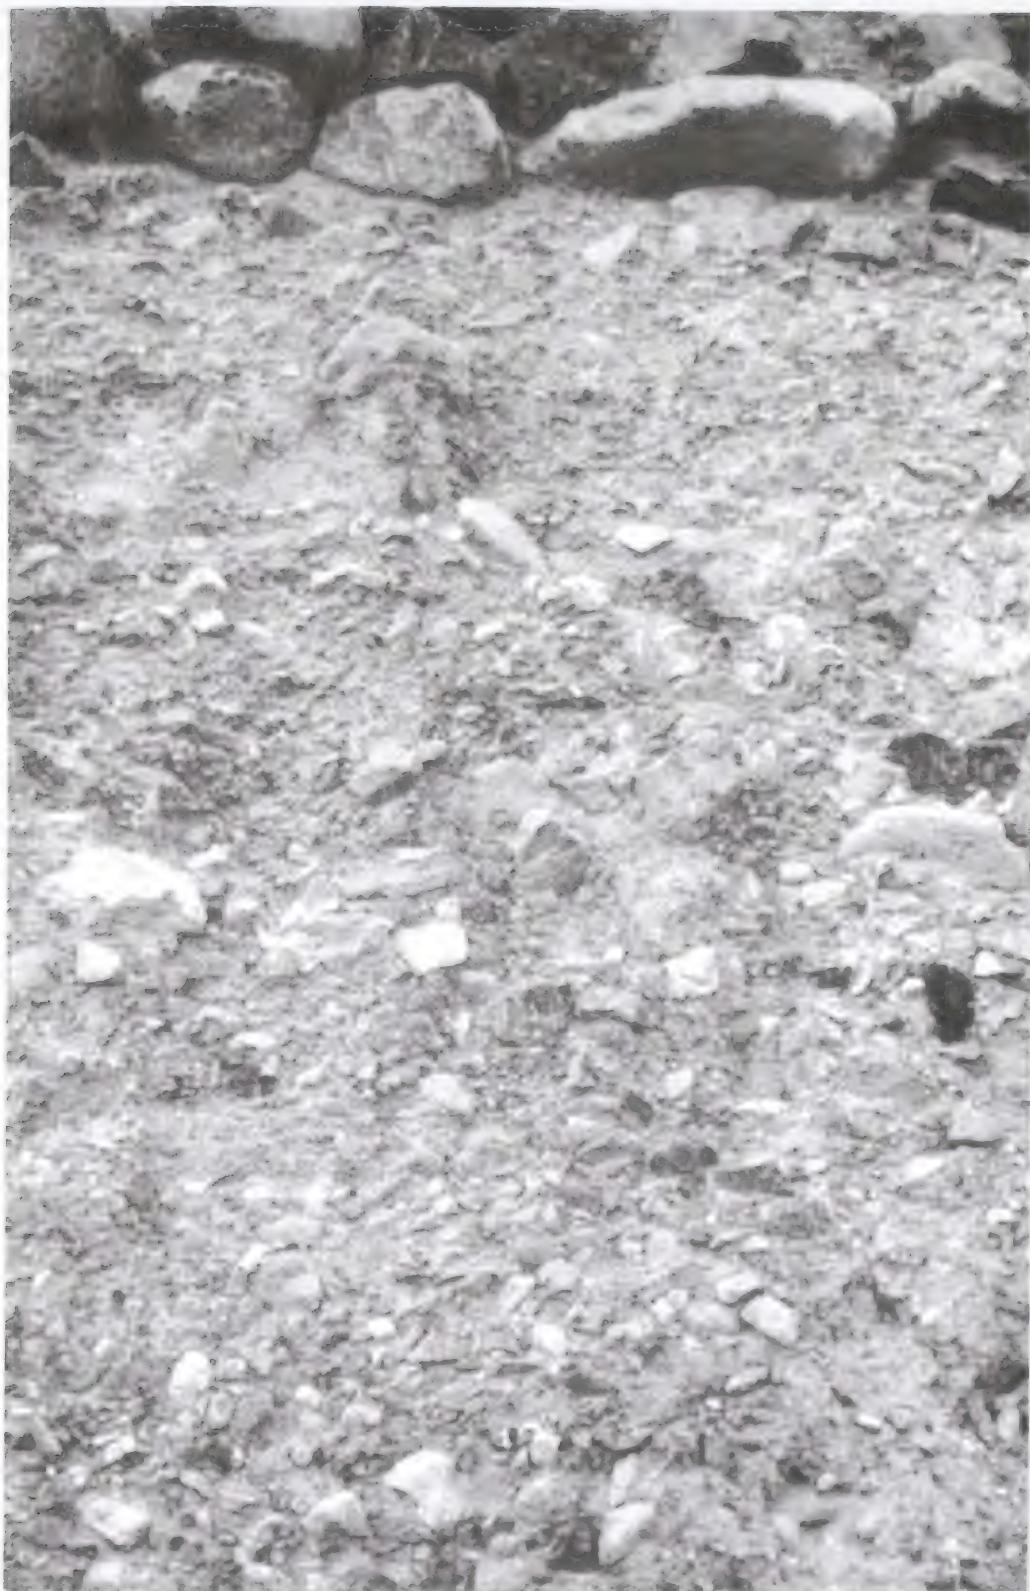
**5. Section of the conglomerate showing the composition with bigger sized pebbles.**

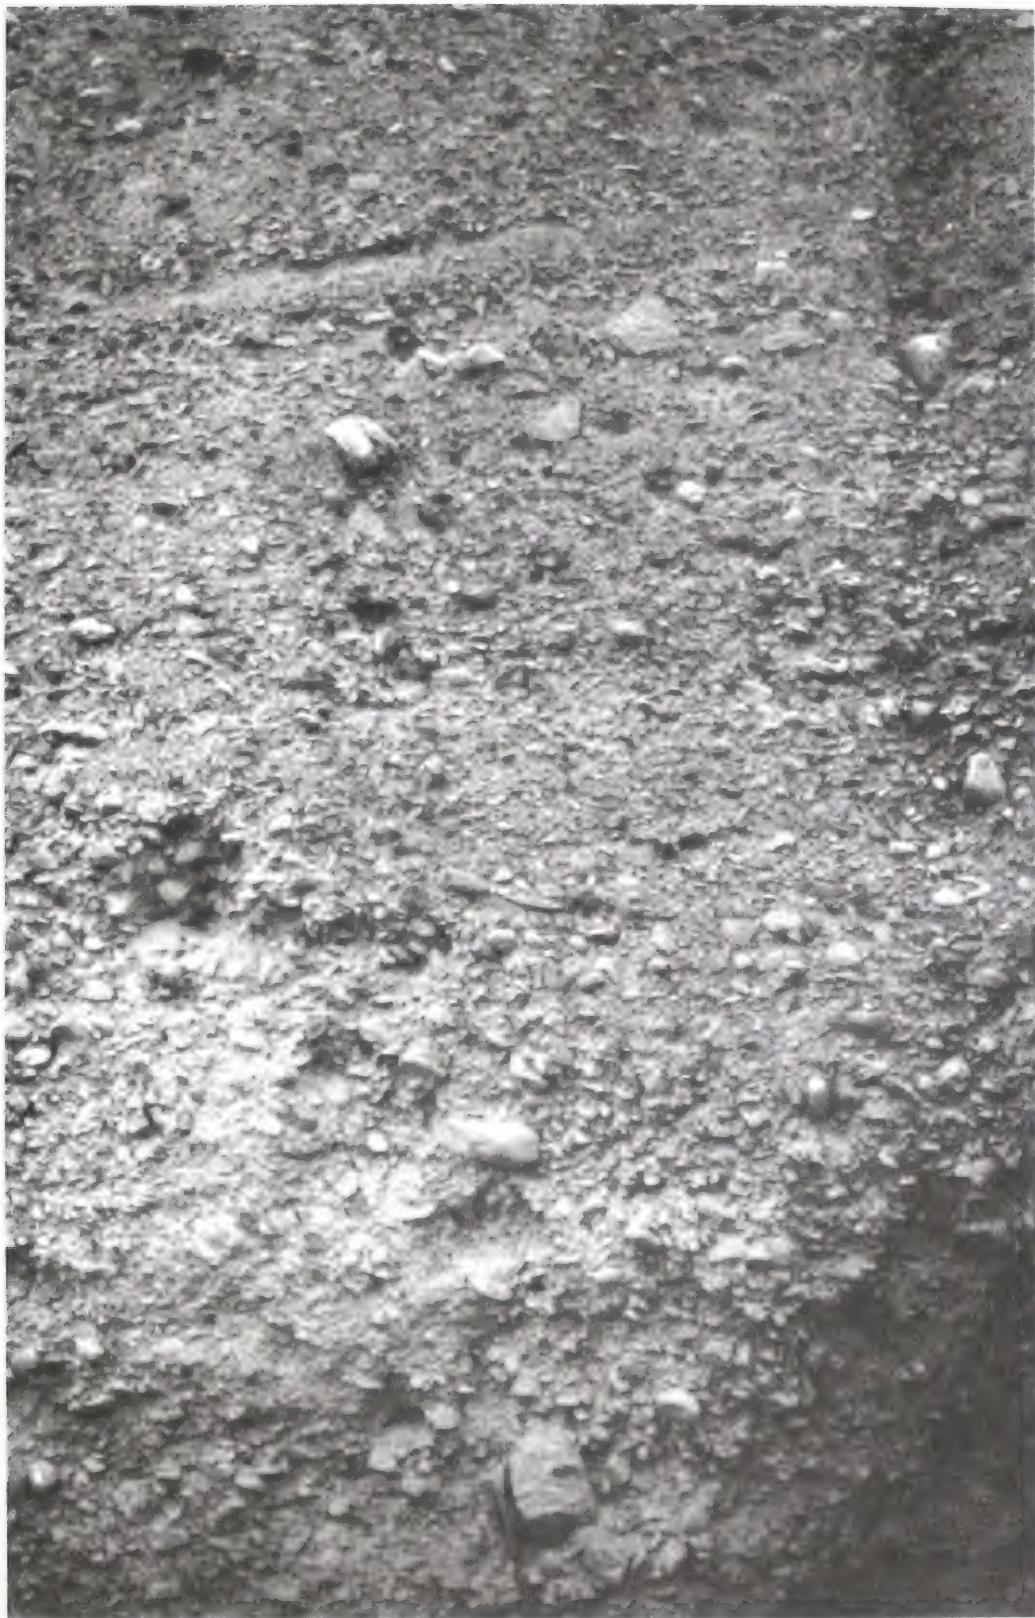
**6. Exposed section of the conglomerate showing the composition with gravels.**

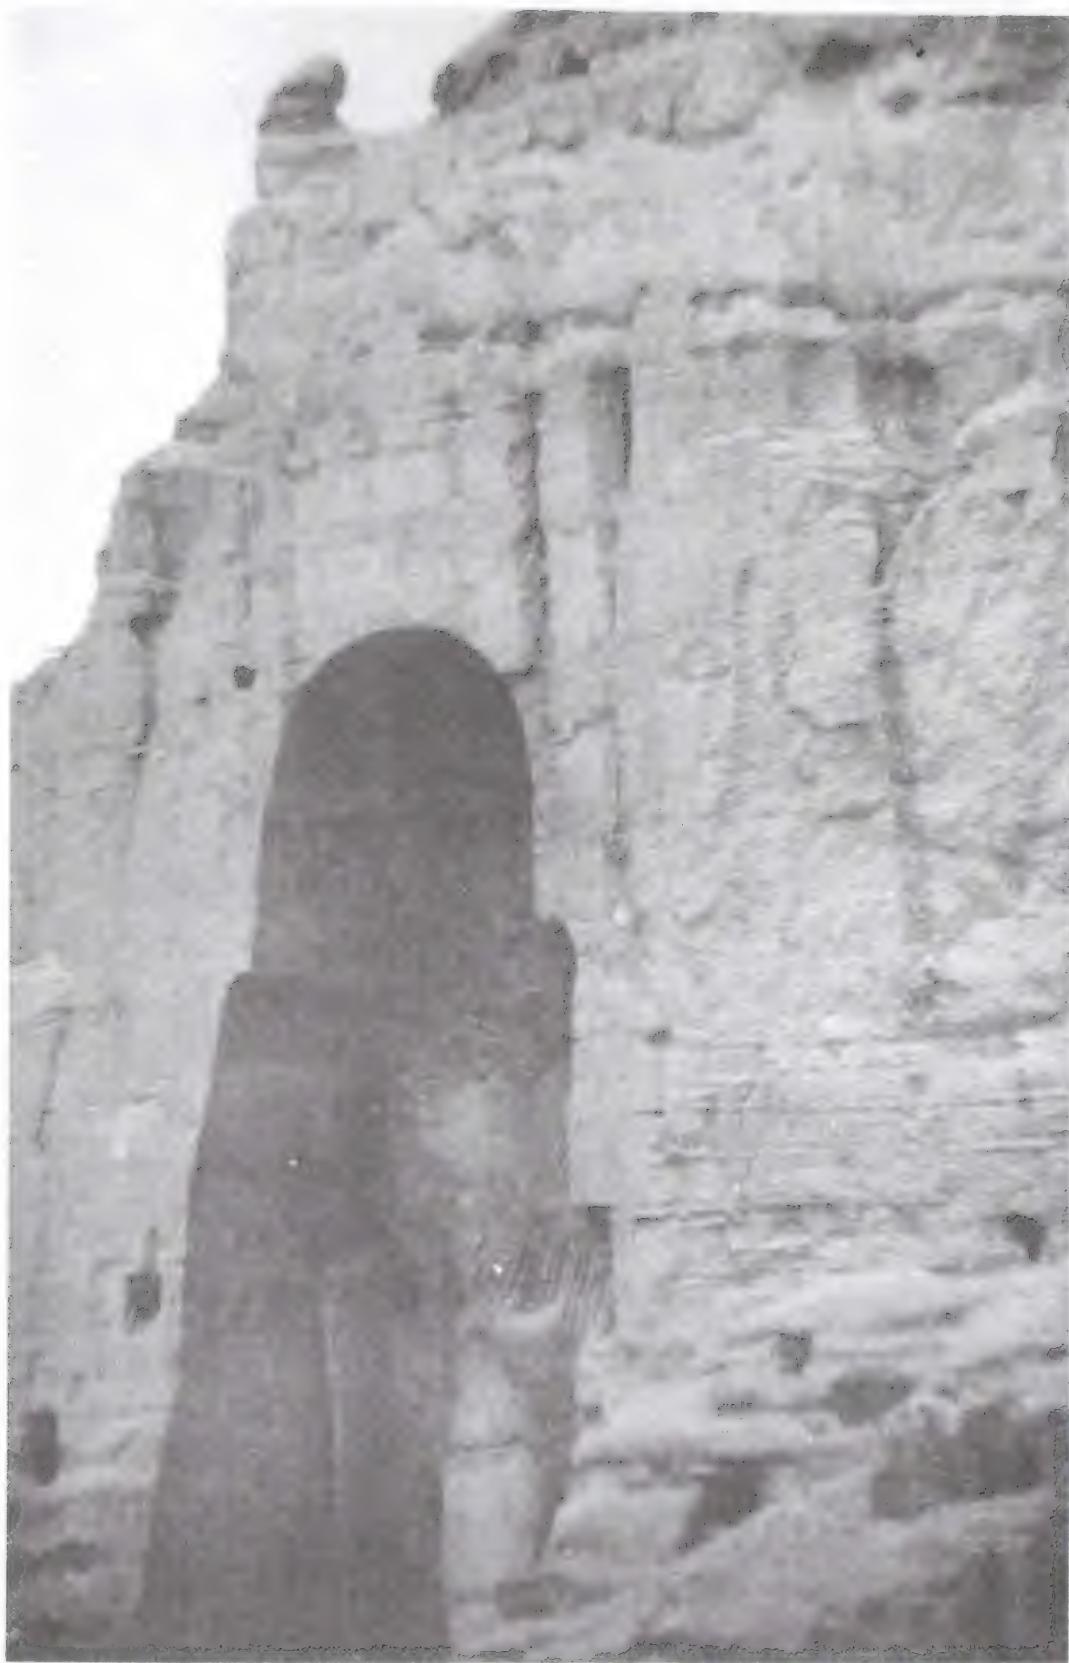
The rock on the facade has decayed most due to exposure; long scars have been formed due to flow of water from the top and pieces of stones have disappeared leaving the overlying masses hanging as will be seen in the photograph especially under the points 'D' and 'E'. The portion hanging under 'D' needs underpinning in cement concrete with pins inserted in the rock. The made-up surface should have an outward slope. Similarly, the cavity found under point 'E' should be filled up to support the pieces above which there are cracks around it. It will be necessary to fix this piece by inserting pins and grout the cracks to stop entry of water through them.

**9. Facade of the rock around the niche of the Big Buddha.**

The long scars mentioned above will have to be filled in upto the level of the rock-surface with cement concrete. The tin-shed provided beyond the entrance, leading to the rock-out passage at the top, should be replaced with one of reinforced cement concrete with sufficient bearing on the walls to prevent any leakage. In the past water coming from the top used to find passage along the steps and reach the west well of the niches, through an opening, and did much damage to the paintings. The R.C.C. Roof slab should be given a covering of earth to work as insulation against the variable temperature and a steep slope for easy drainage away from the niche-front.

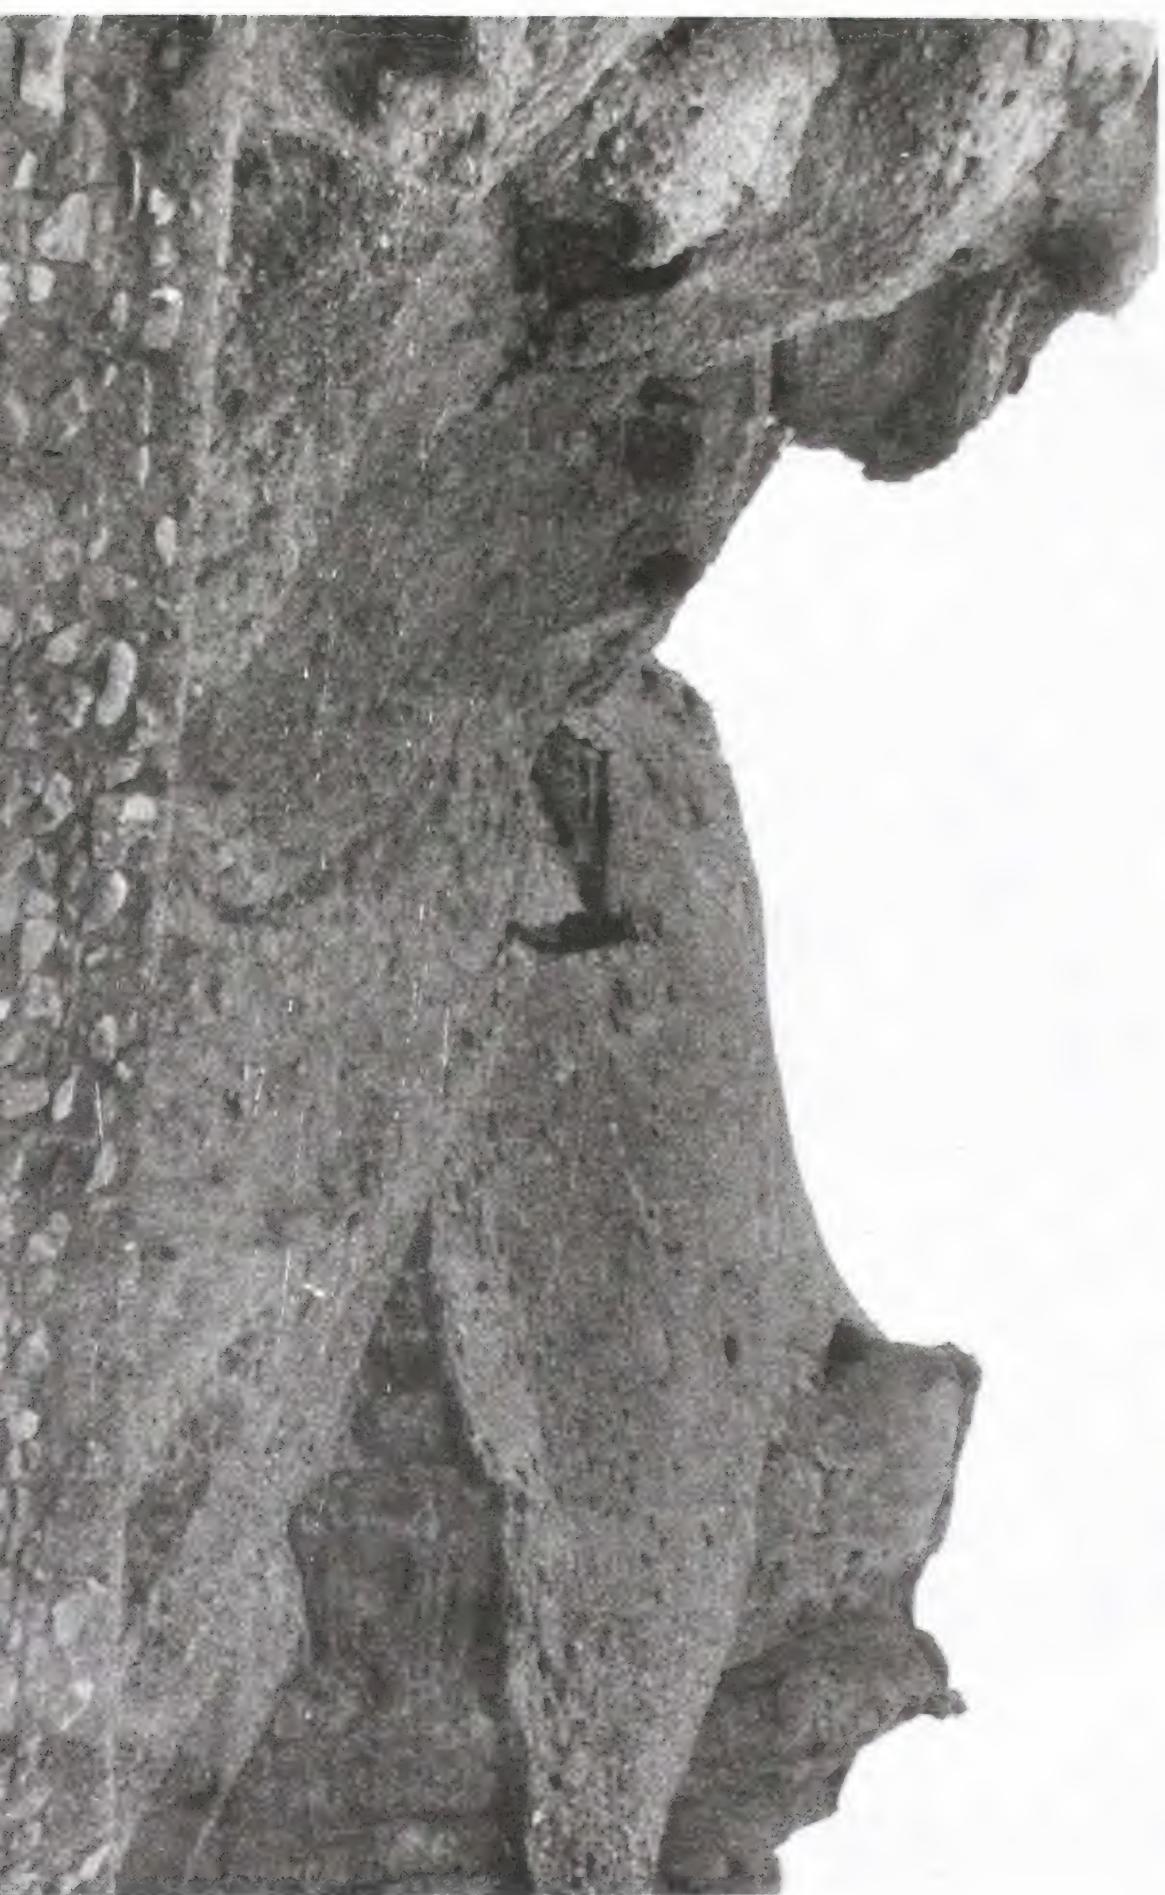
13. The damage feet of the Big Buddha.

**P1.V,10:** But, there are other typical problems. For example, the Big Buddha which reportedly had received cannon shots has developed several cracks and portions of its limbs are hanging which need supporting. In the case of the Small Buddha, replacing the incongruous brick-wall with one of concrete is of considerable importance as the question of supporting the severed portion at the top has also to be dealt with simultaneously.

**13. The damaged feet of the Big Buddha.**

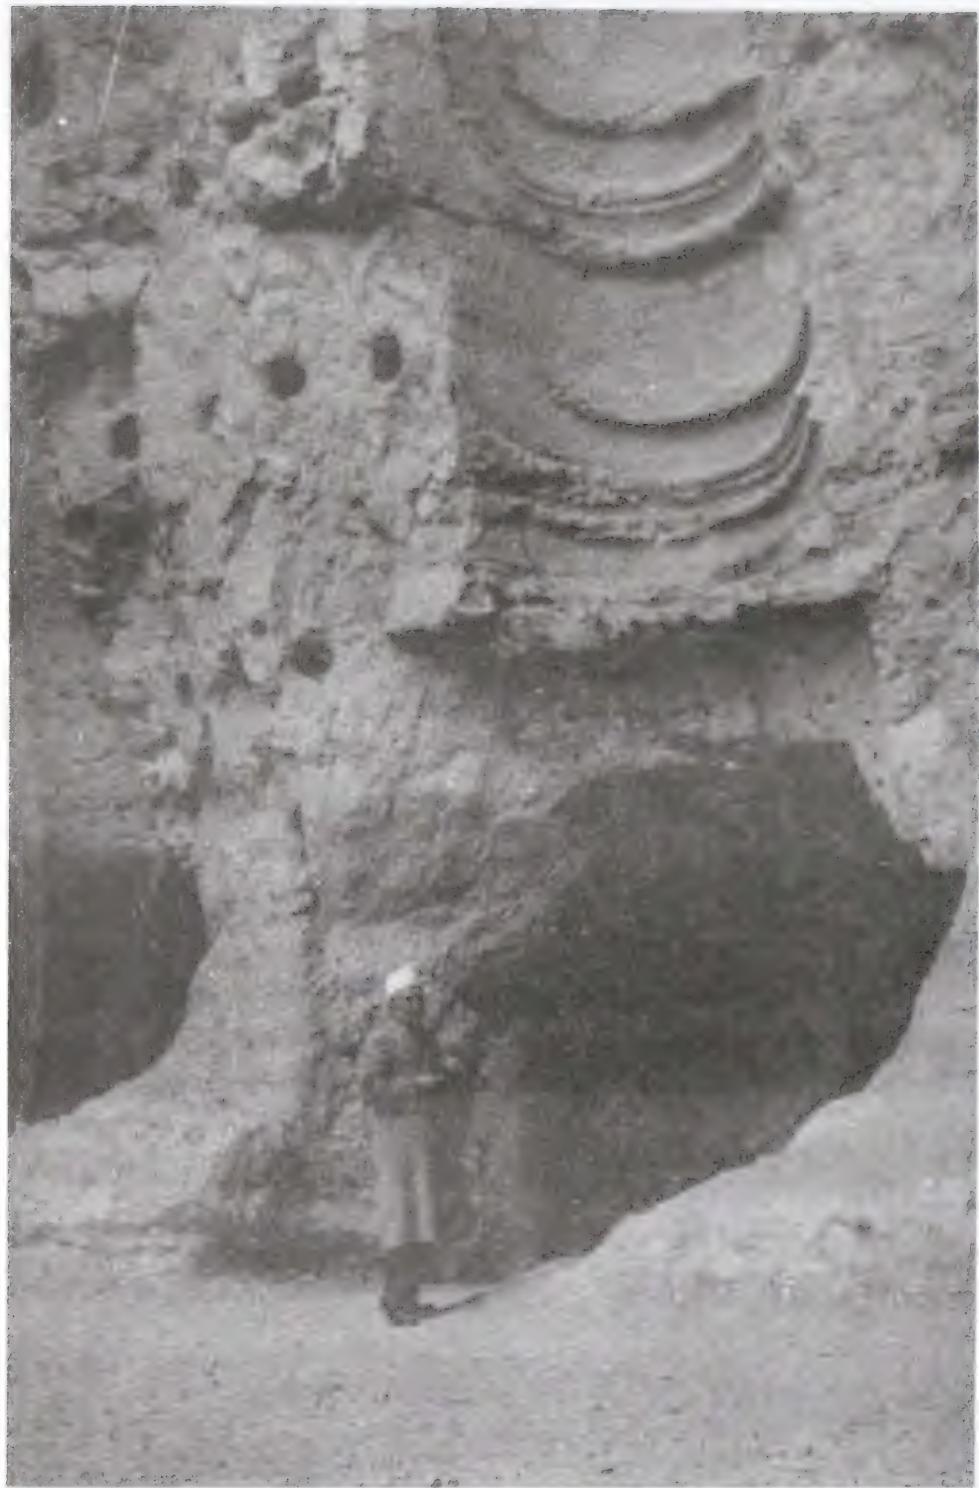
**P1, VII, 13** The image, bigger than the other one and of a later date, is in worse condition. The ankles and feet have suffered most. The portion below the thigh of the left leg and that from the knee downwards of the right leg have disappeared leaving the upper portions overhanging. The result being that several cracks have developed in the region and the joints between the layers of conglomerate have widened. The horizontal crack below the waist spread across the body is of the latter type. After filling up the cracks and securing the cracked places with pins, supports will have to be provided from below in R.C.C. and the surface finished rough. The heels repaired in the recent past with kagol (mud plaster) should be dismantled and redone in cement concrete. The folds of the sanghati (garment) especially on the belly are disturbed and have been secured with the help of strings. These folds need partial restoration and resetting at their places with copper pins.

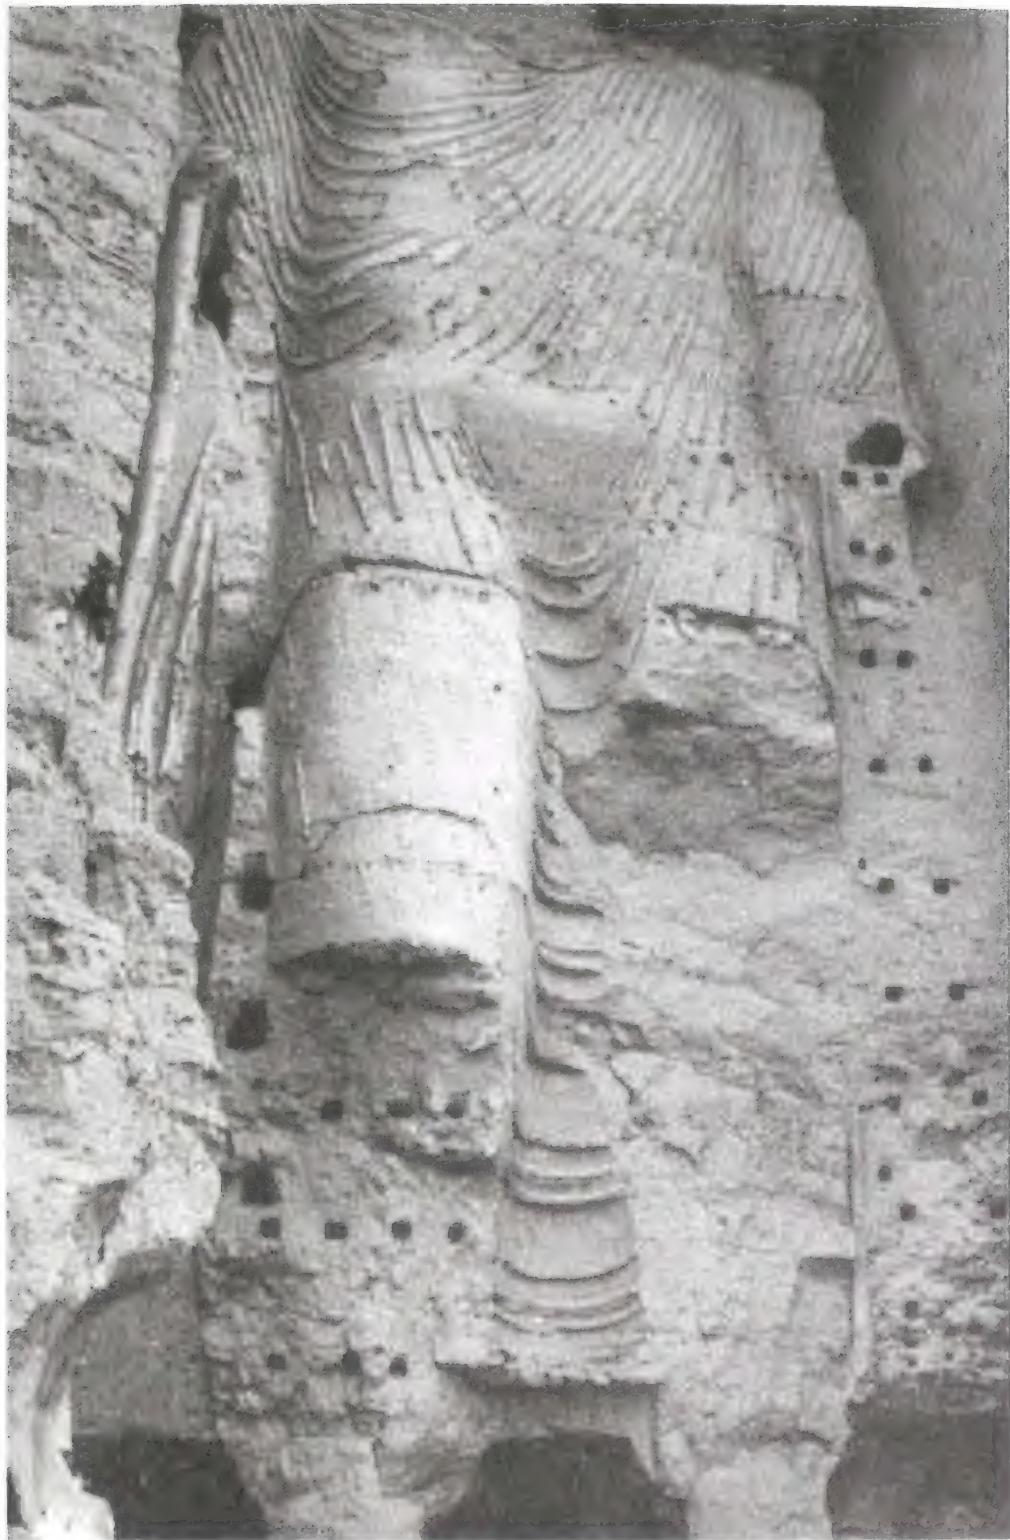
**14. Bamiyan. The Big Buddha  
Afghanistan showing crack in the body.**

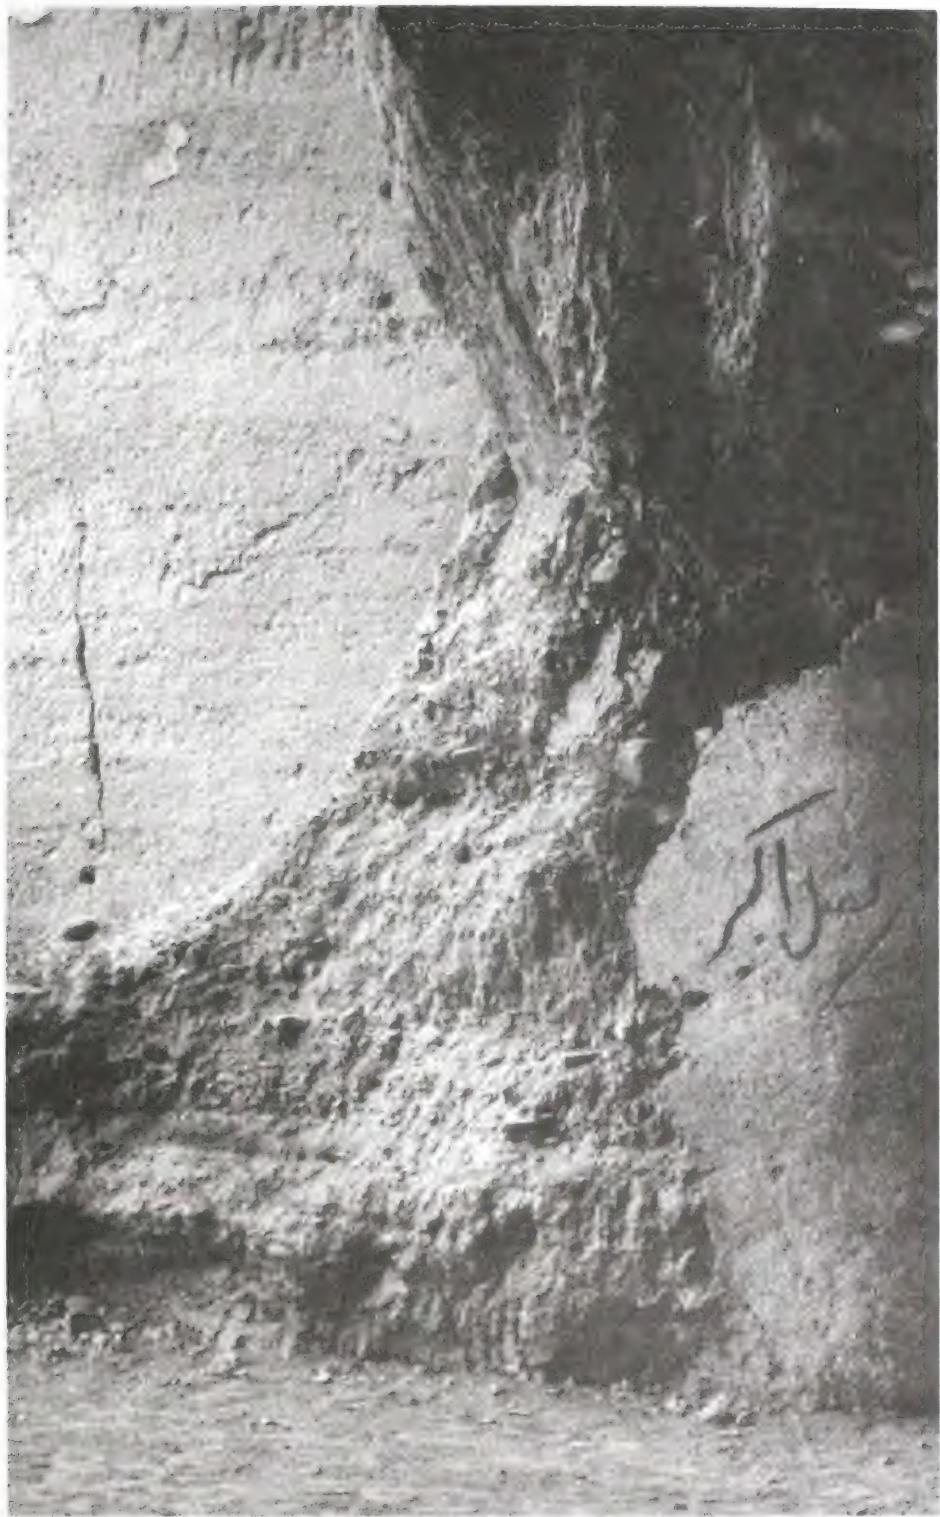
**16. The damaged heel of the right foot of the Big Buddha.**

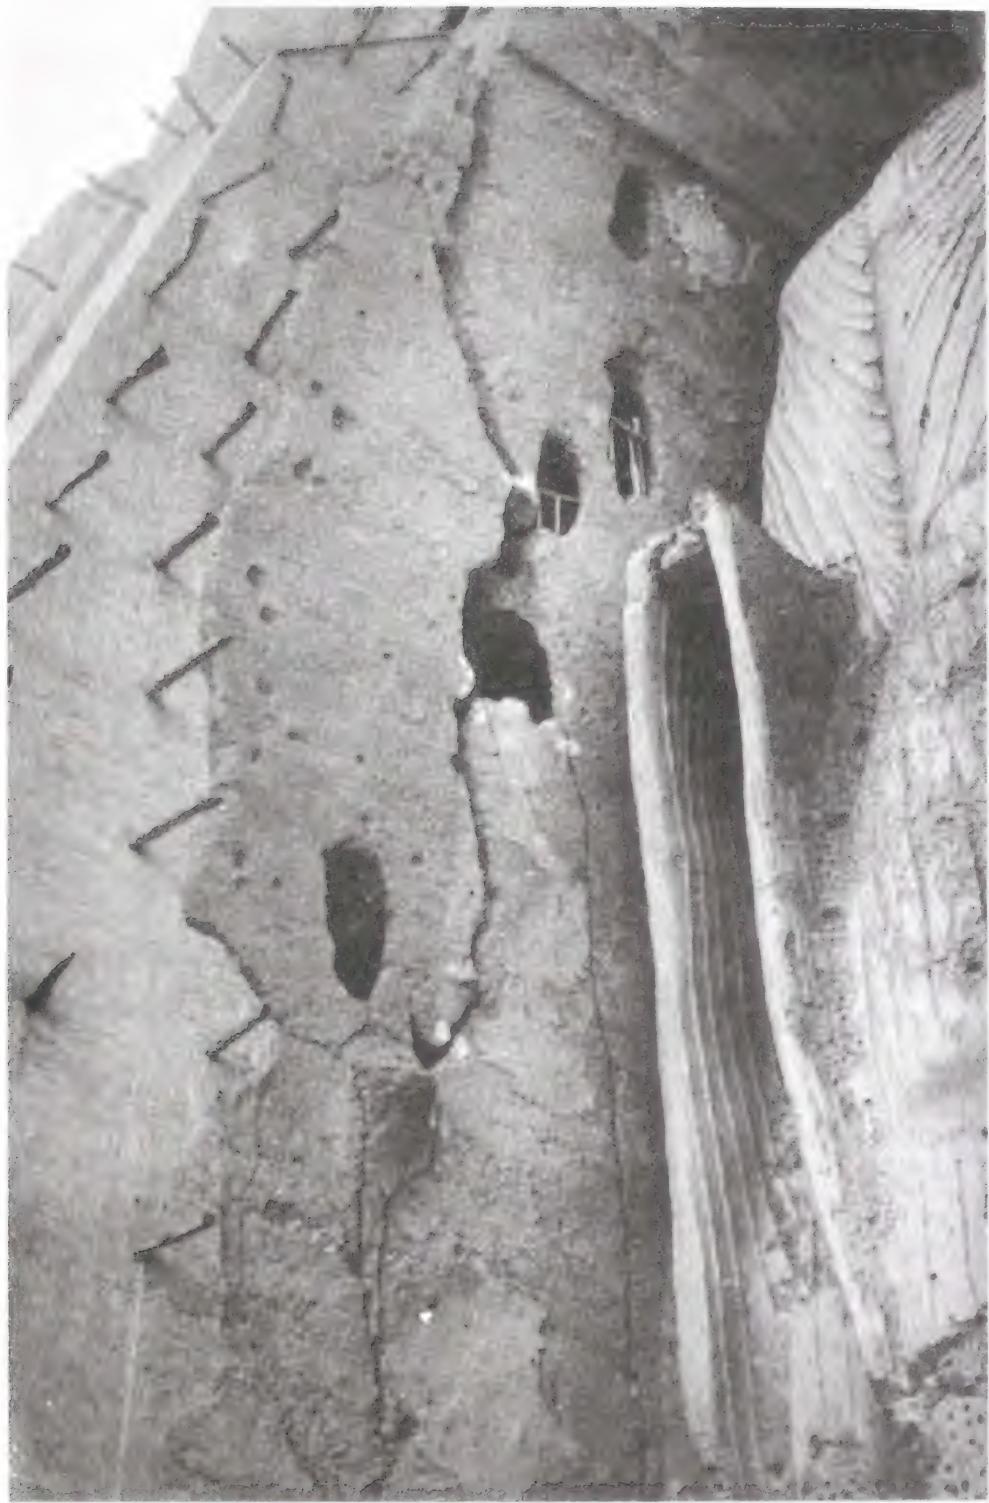
**18. Cracks on the western wall of the niche of the Small Buddha.**

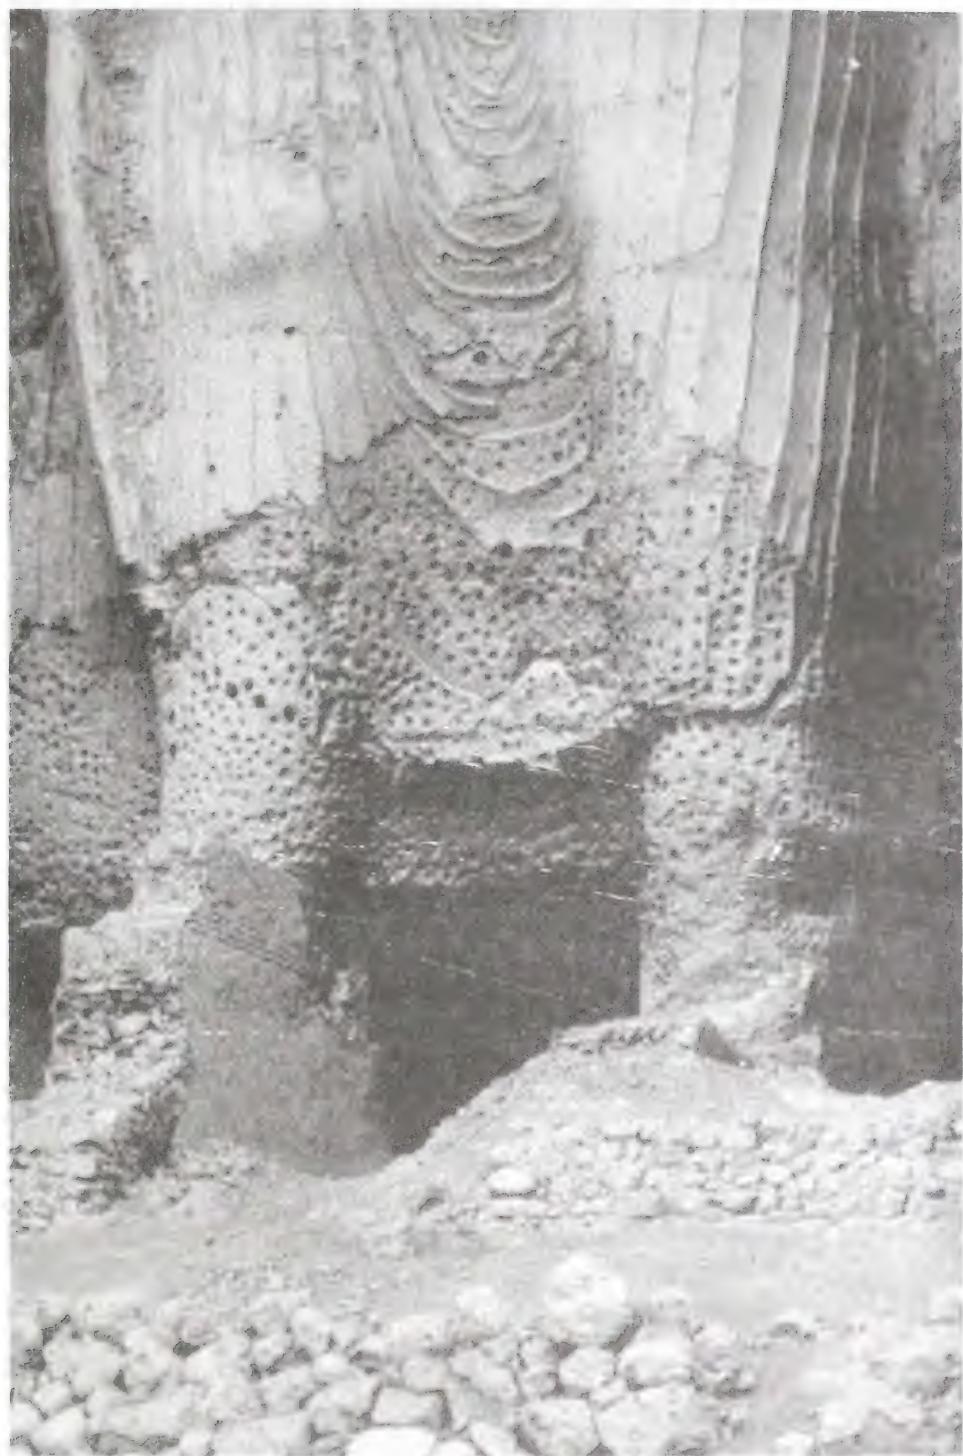
But for the damaged bottom and of course the mutilated face, this image is in a better state of preservation. In the past the damaged feet were given each a masonry support and a wall was also erected behind the supports. These walls mostly in a collapsed state now present a very bad appearance. After cleaning the walls and the debris the damaged feet are to be repaired in cement concrete. The fractured portion of the right leg should be pinned with the rock behind.

20. The damaged lower portion of the Small Buddha.

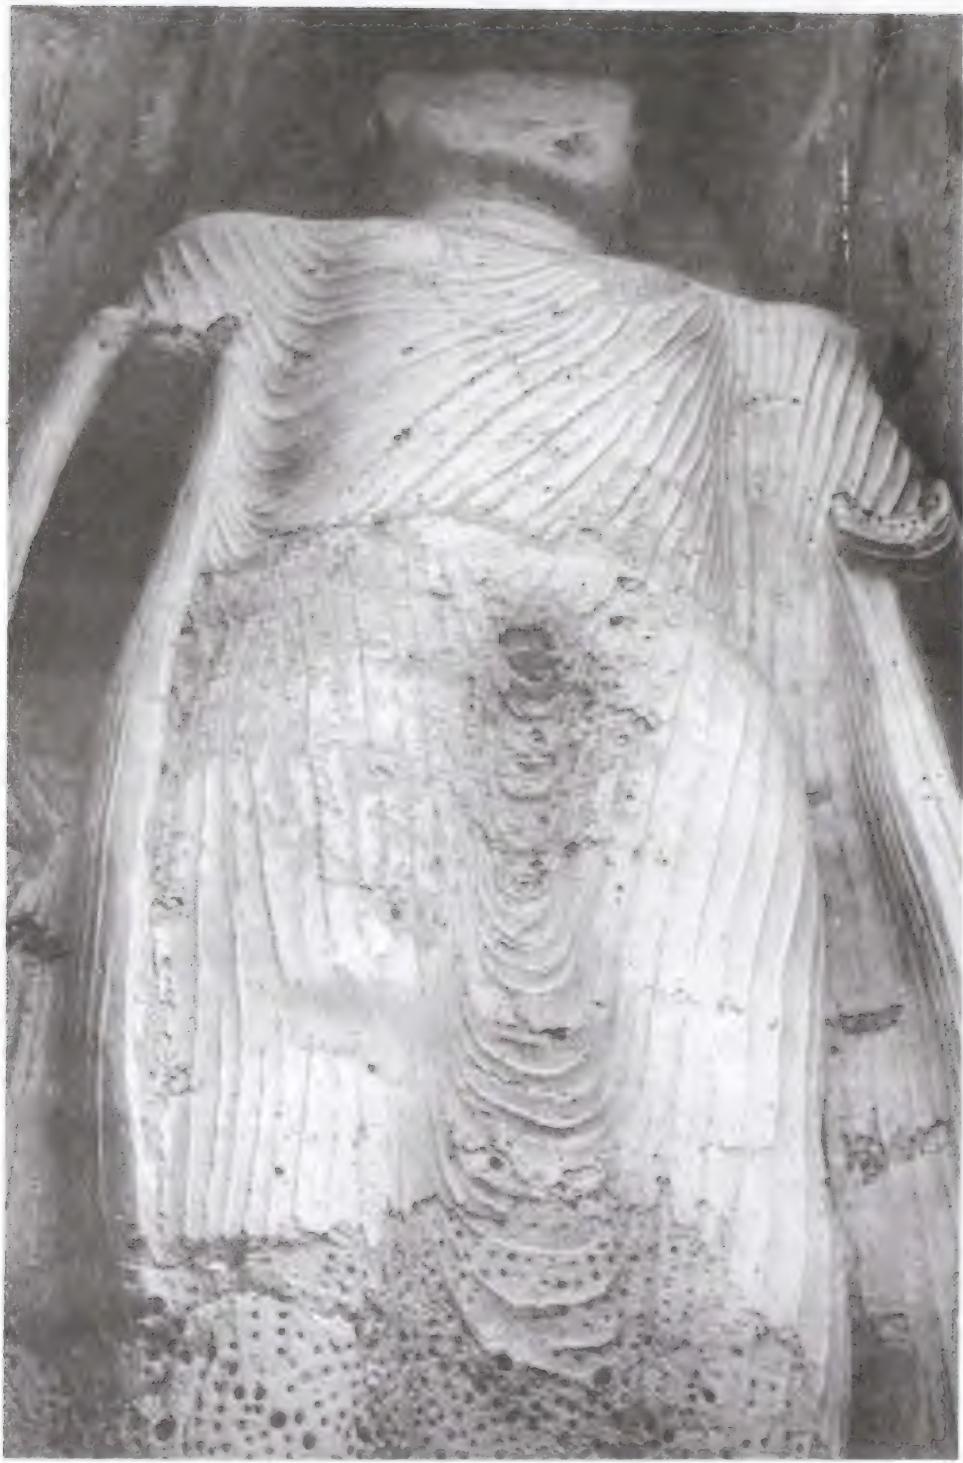
20. The damaged lower portion of the Small Buddha.

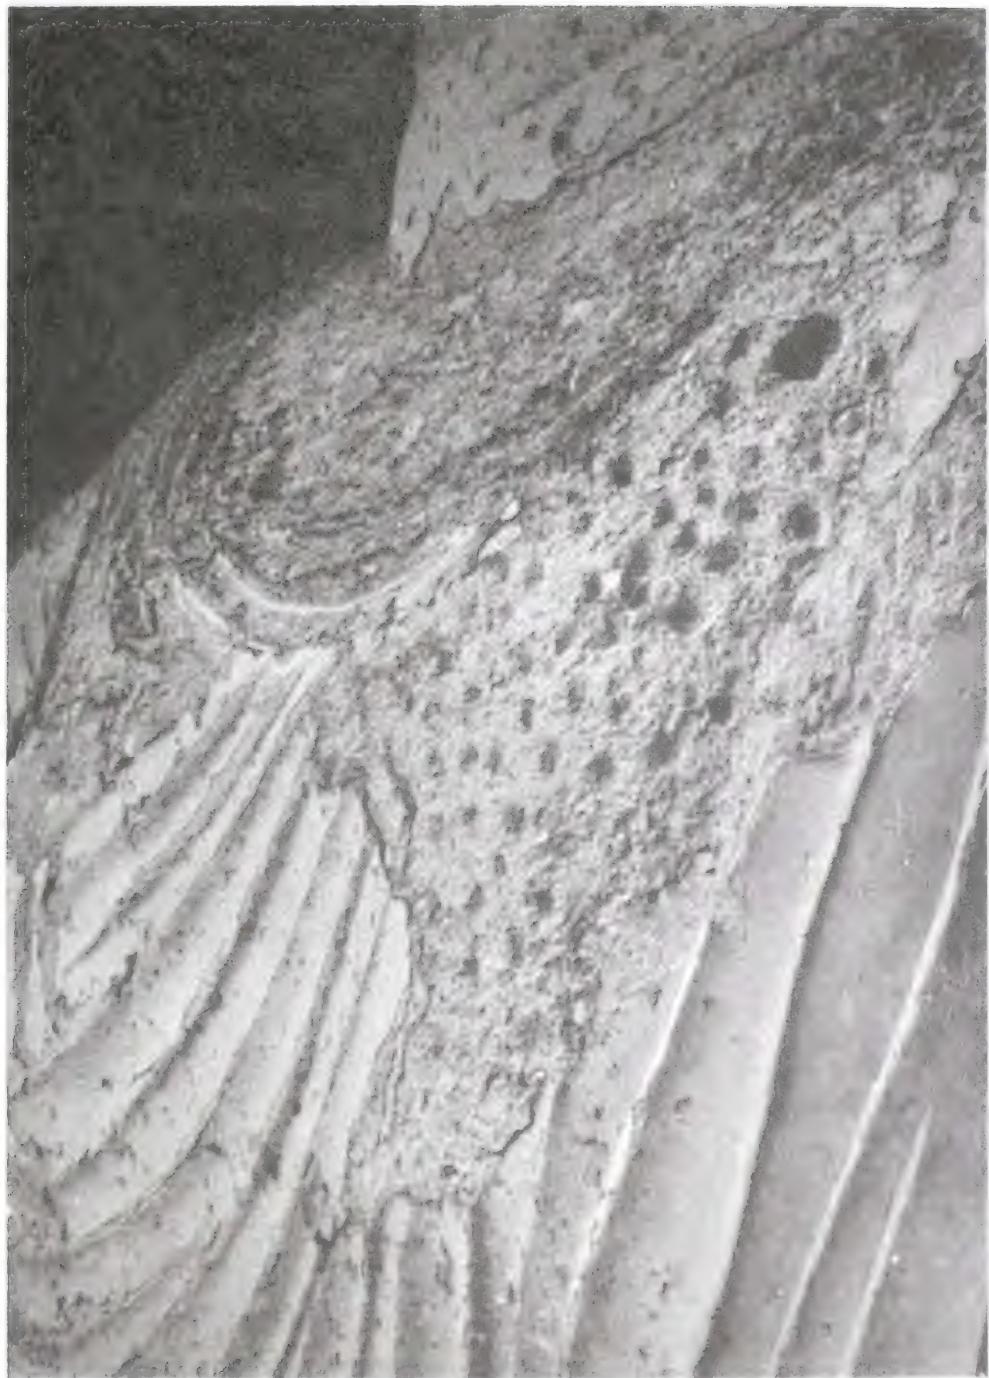
Due to action of water settled on the image the plastered surface of the sanghati (garment), below the waist upto the knee of the right thigh and the zone below the neck with portion of the breast, were abraded and at places pits have formed. Such damages are to be repaired with clay and then the surface treated with water repellent solution. The triangular portion underside the broken right arm has developed a crack and is in danger of being disengaged. This portion should be secured by inserting copper rods from below. The broken edge of the plaster should then be filleted along with other portion requiring similar treatment.

**22. Small Buddha showing the damage portion of the upper garment.**

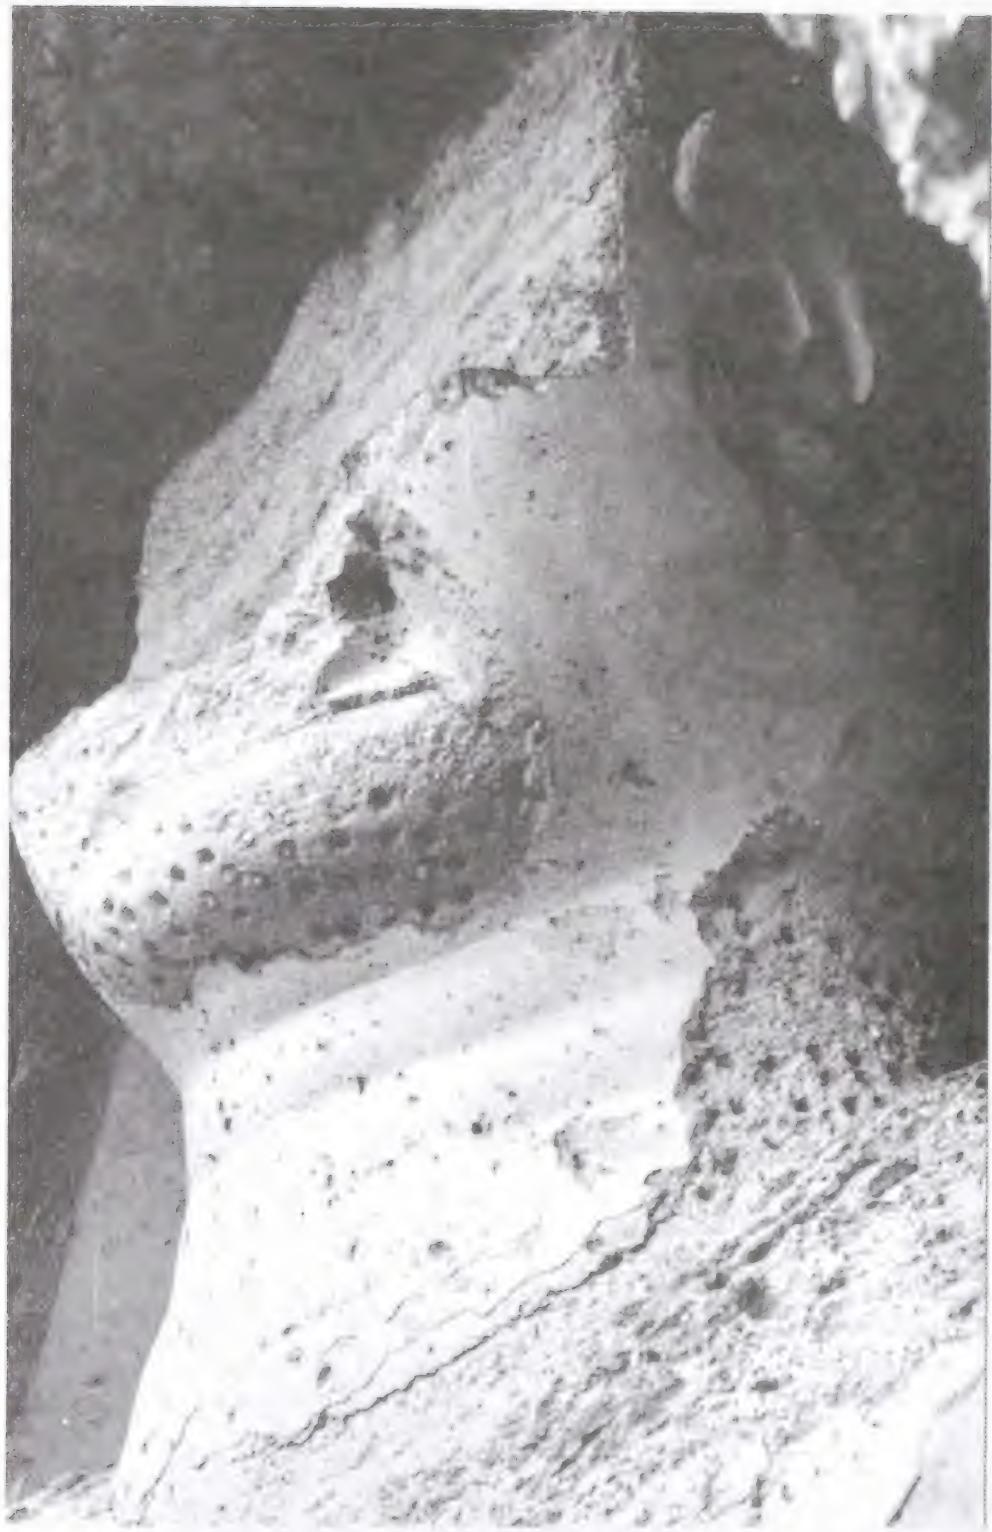
**23. The head of the Small Buddha showing the damaged portion.**

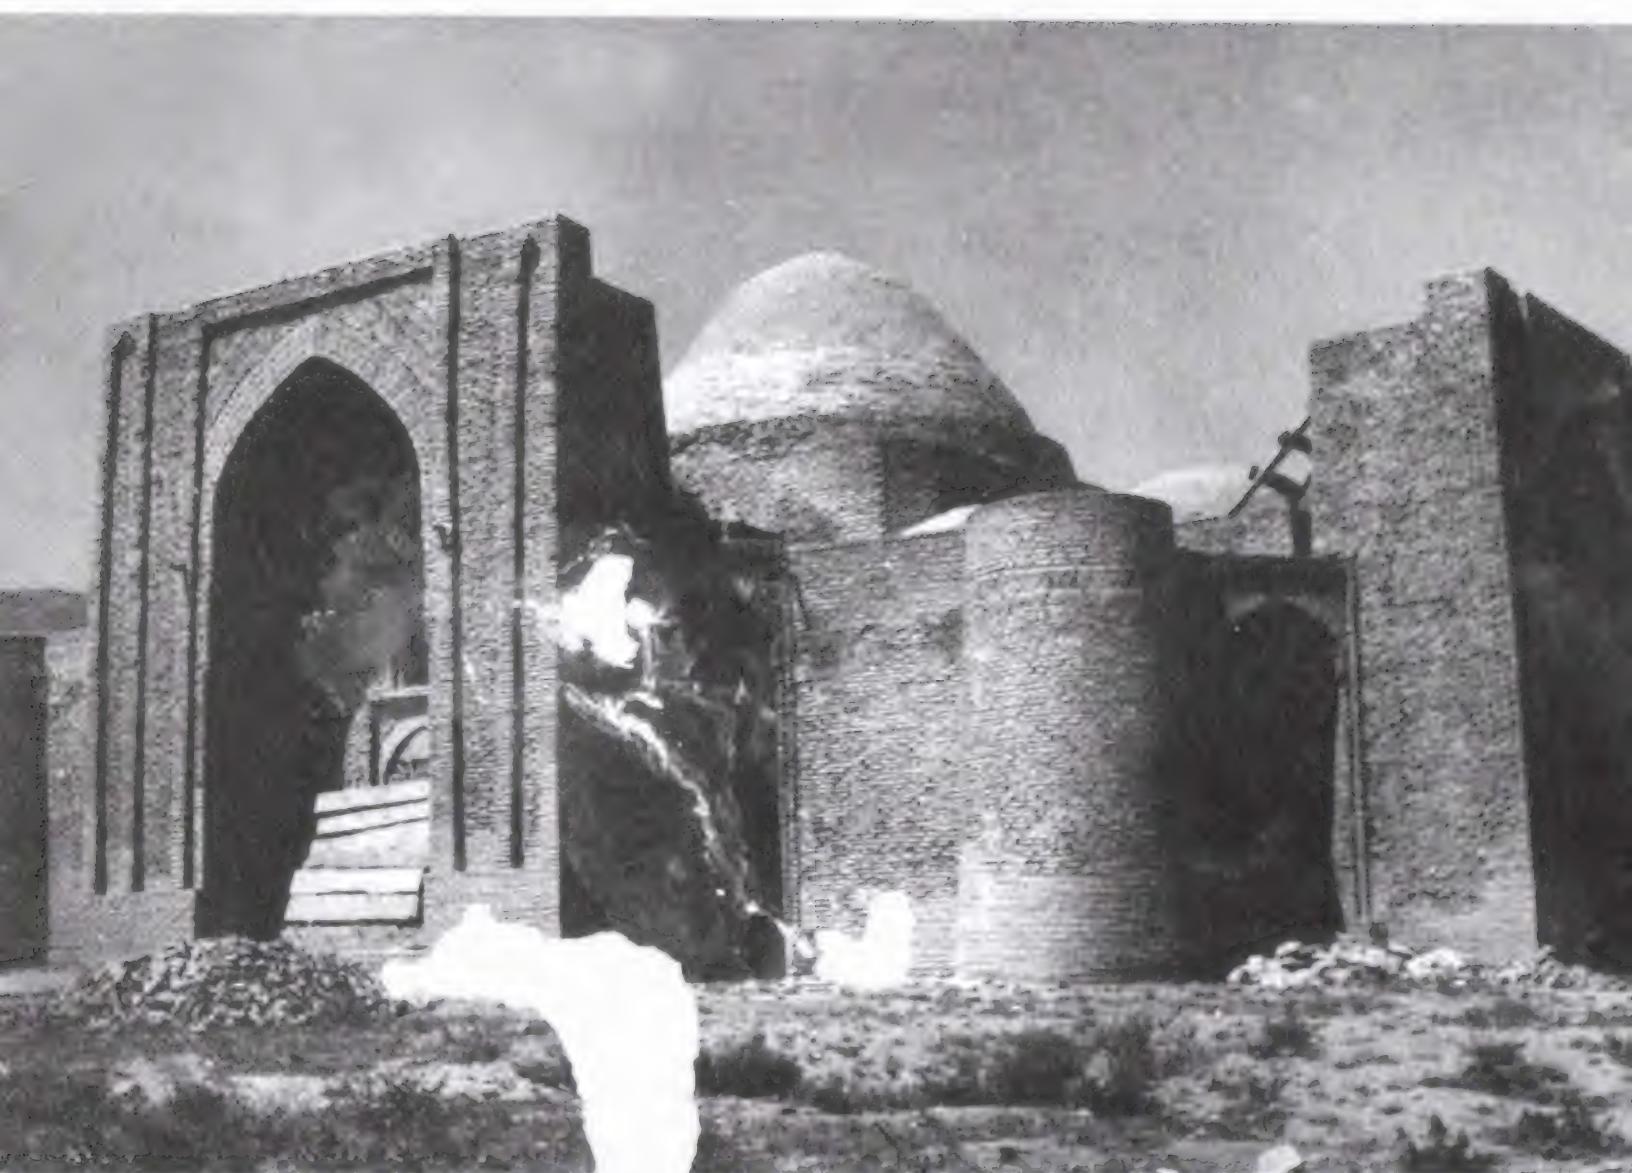
39. Tomb of Abdur Razzaq (as repaired by Italian Mission) at Ghazni.
